RE: Annual 2010 Inspection Report
Star Point Refuse Pile C/007/042

IMPOUNDMENT INSPECTION AND CERTIFIED REPORT

Report Date January 12, 2011
Permit Number C/007/042
Mine Name Star Point Waste Fuel
Company Name Sunnyside Cogeneration Associates

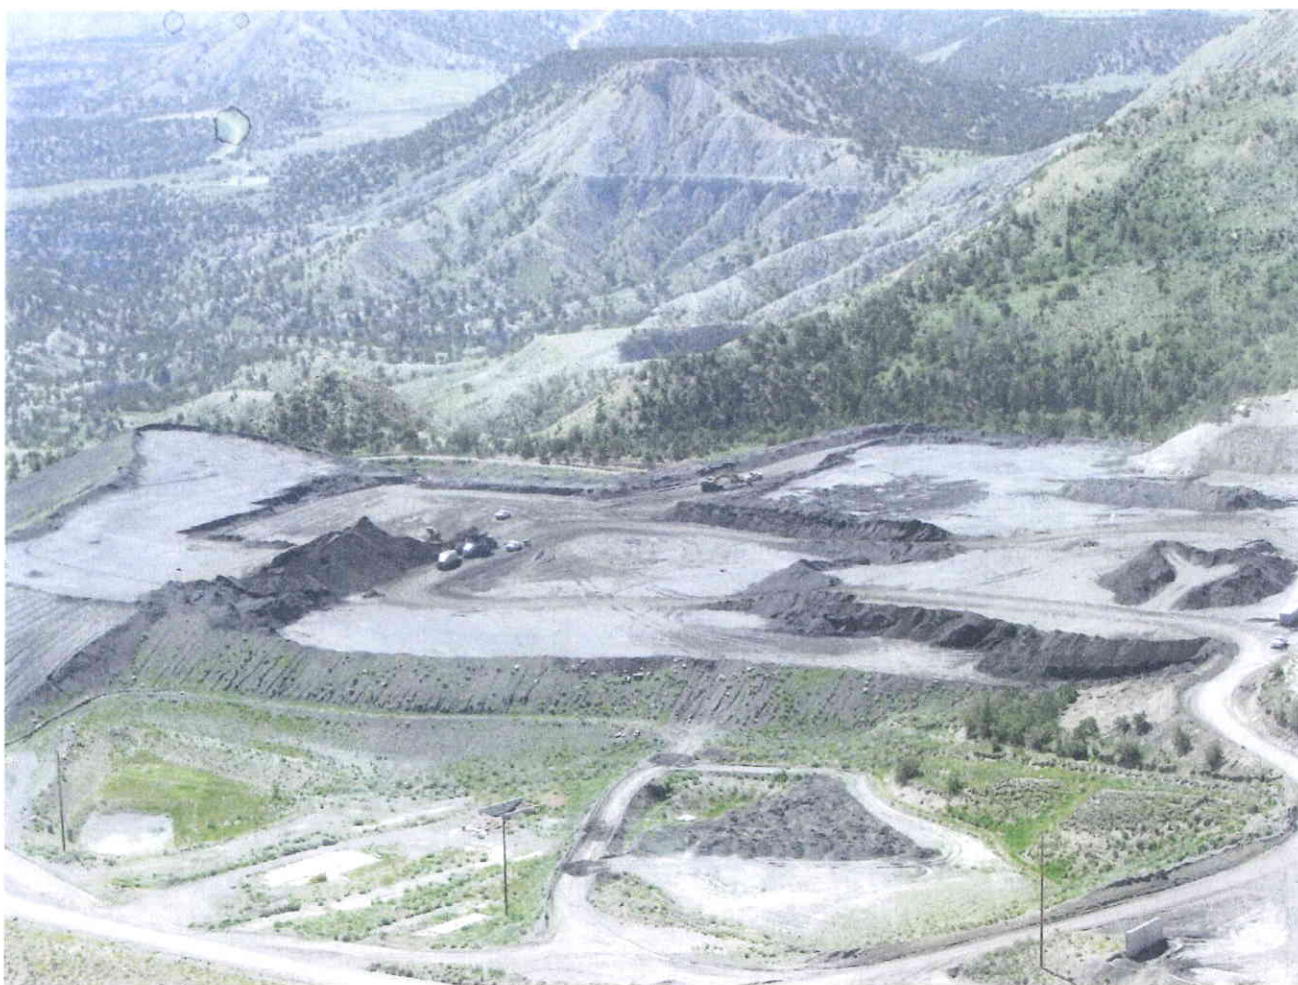
Coarse Refuse Pile A

Refuse material is actively being excavated and removed from the top of the pile

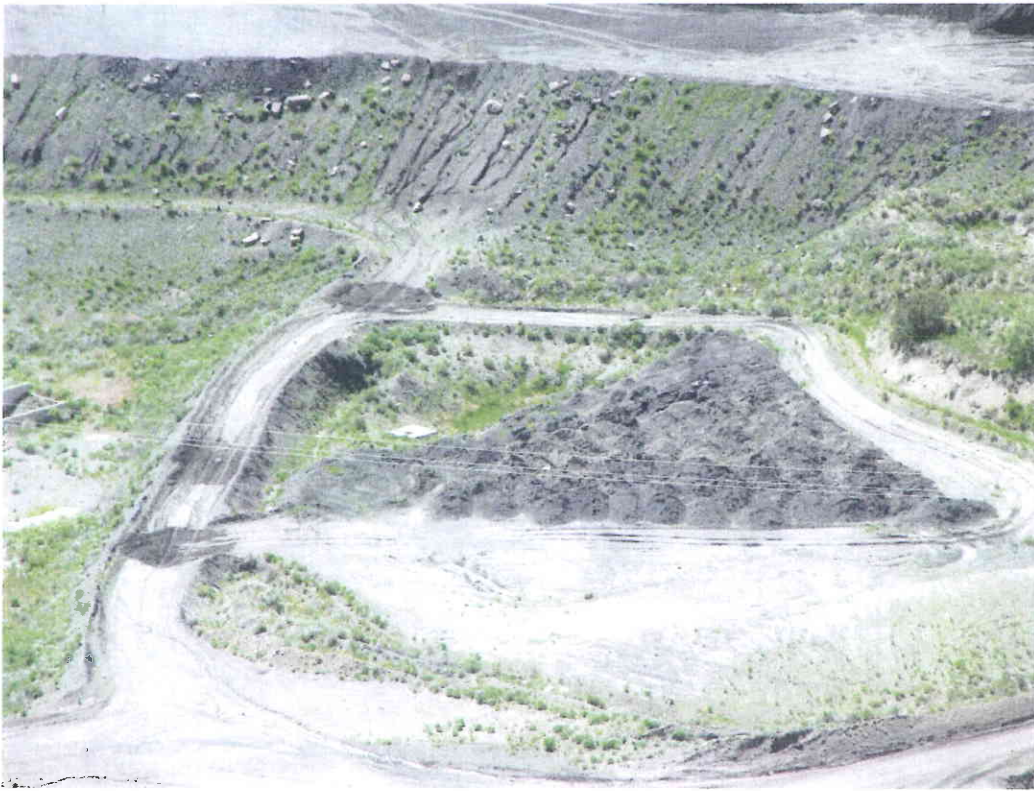
Disposal Area

The disposal area did not receive any materials during the year.

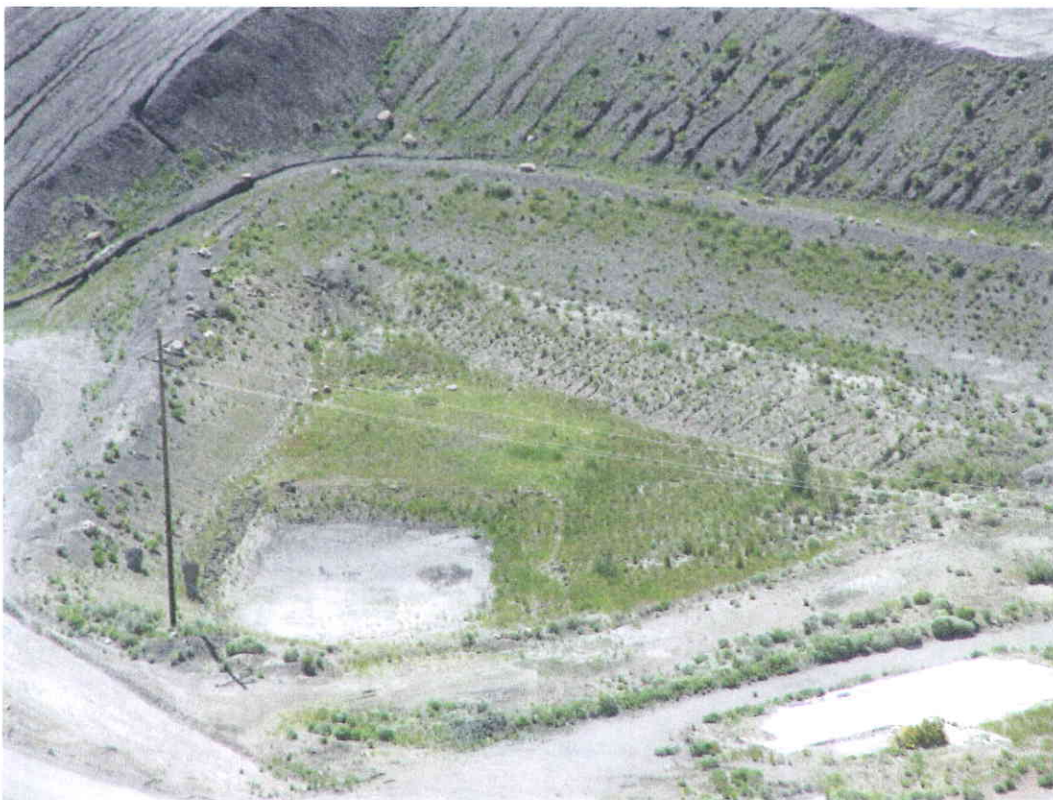
Sediment Pond #9

Pond had some water in it. No samples were taken. Pond did not require decanting.
Sediment levels were reasonable.
Embankment conditions were good. Vegetation on outslopes was adequate.
Inlet / Outlet conditions were good. No structural or hazardous conditions were observed.
